**FINAL PHASE I RFI/RI REPORT
WALNUT CREEK
PRIORITY DRAINAGE
OPERABLE UNIT 6**

**SECTIONS 1.0, 2.0, and 3.0
TEXT, TABLES, AND FIGURES**

**U.S. Department of Energy
Rocky Flats Environmental Technology Site
Golden, Colorado**

February 1996

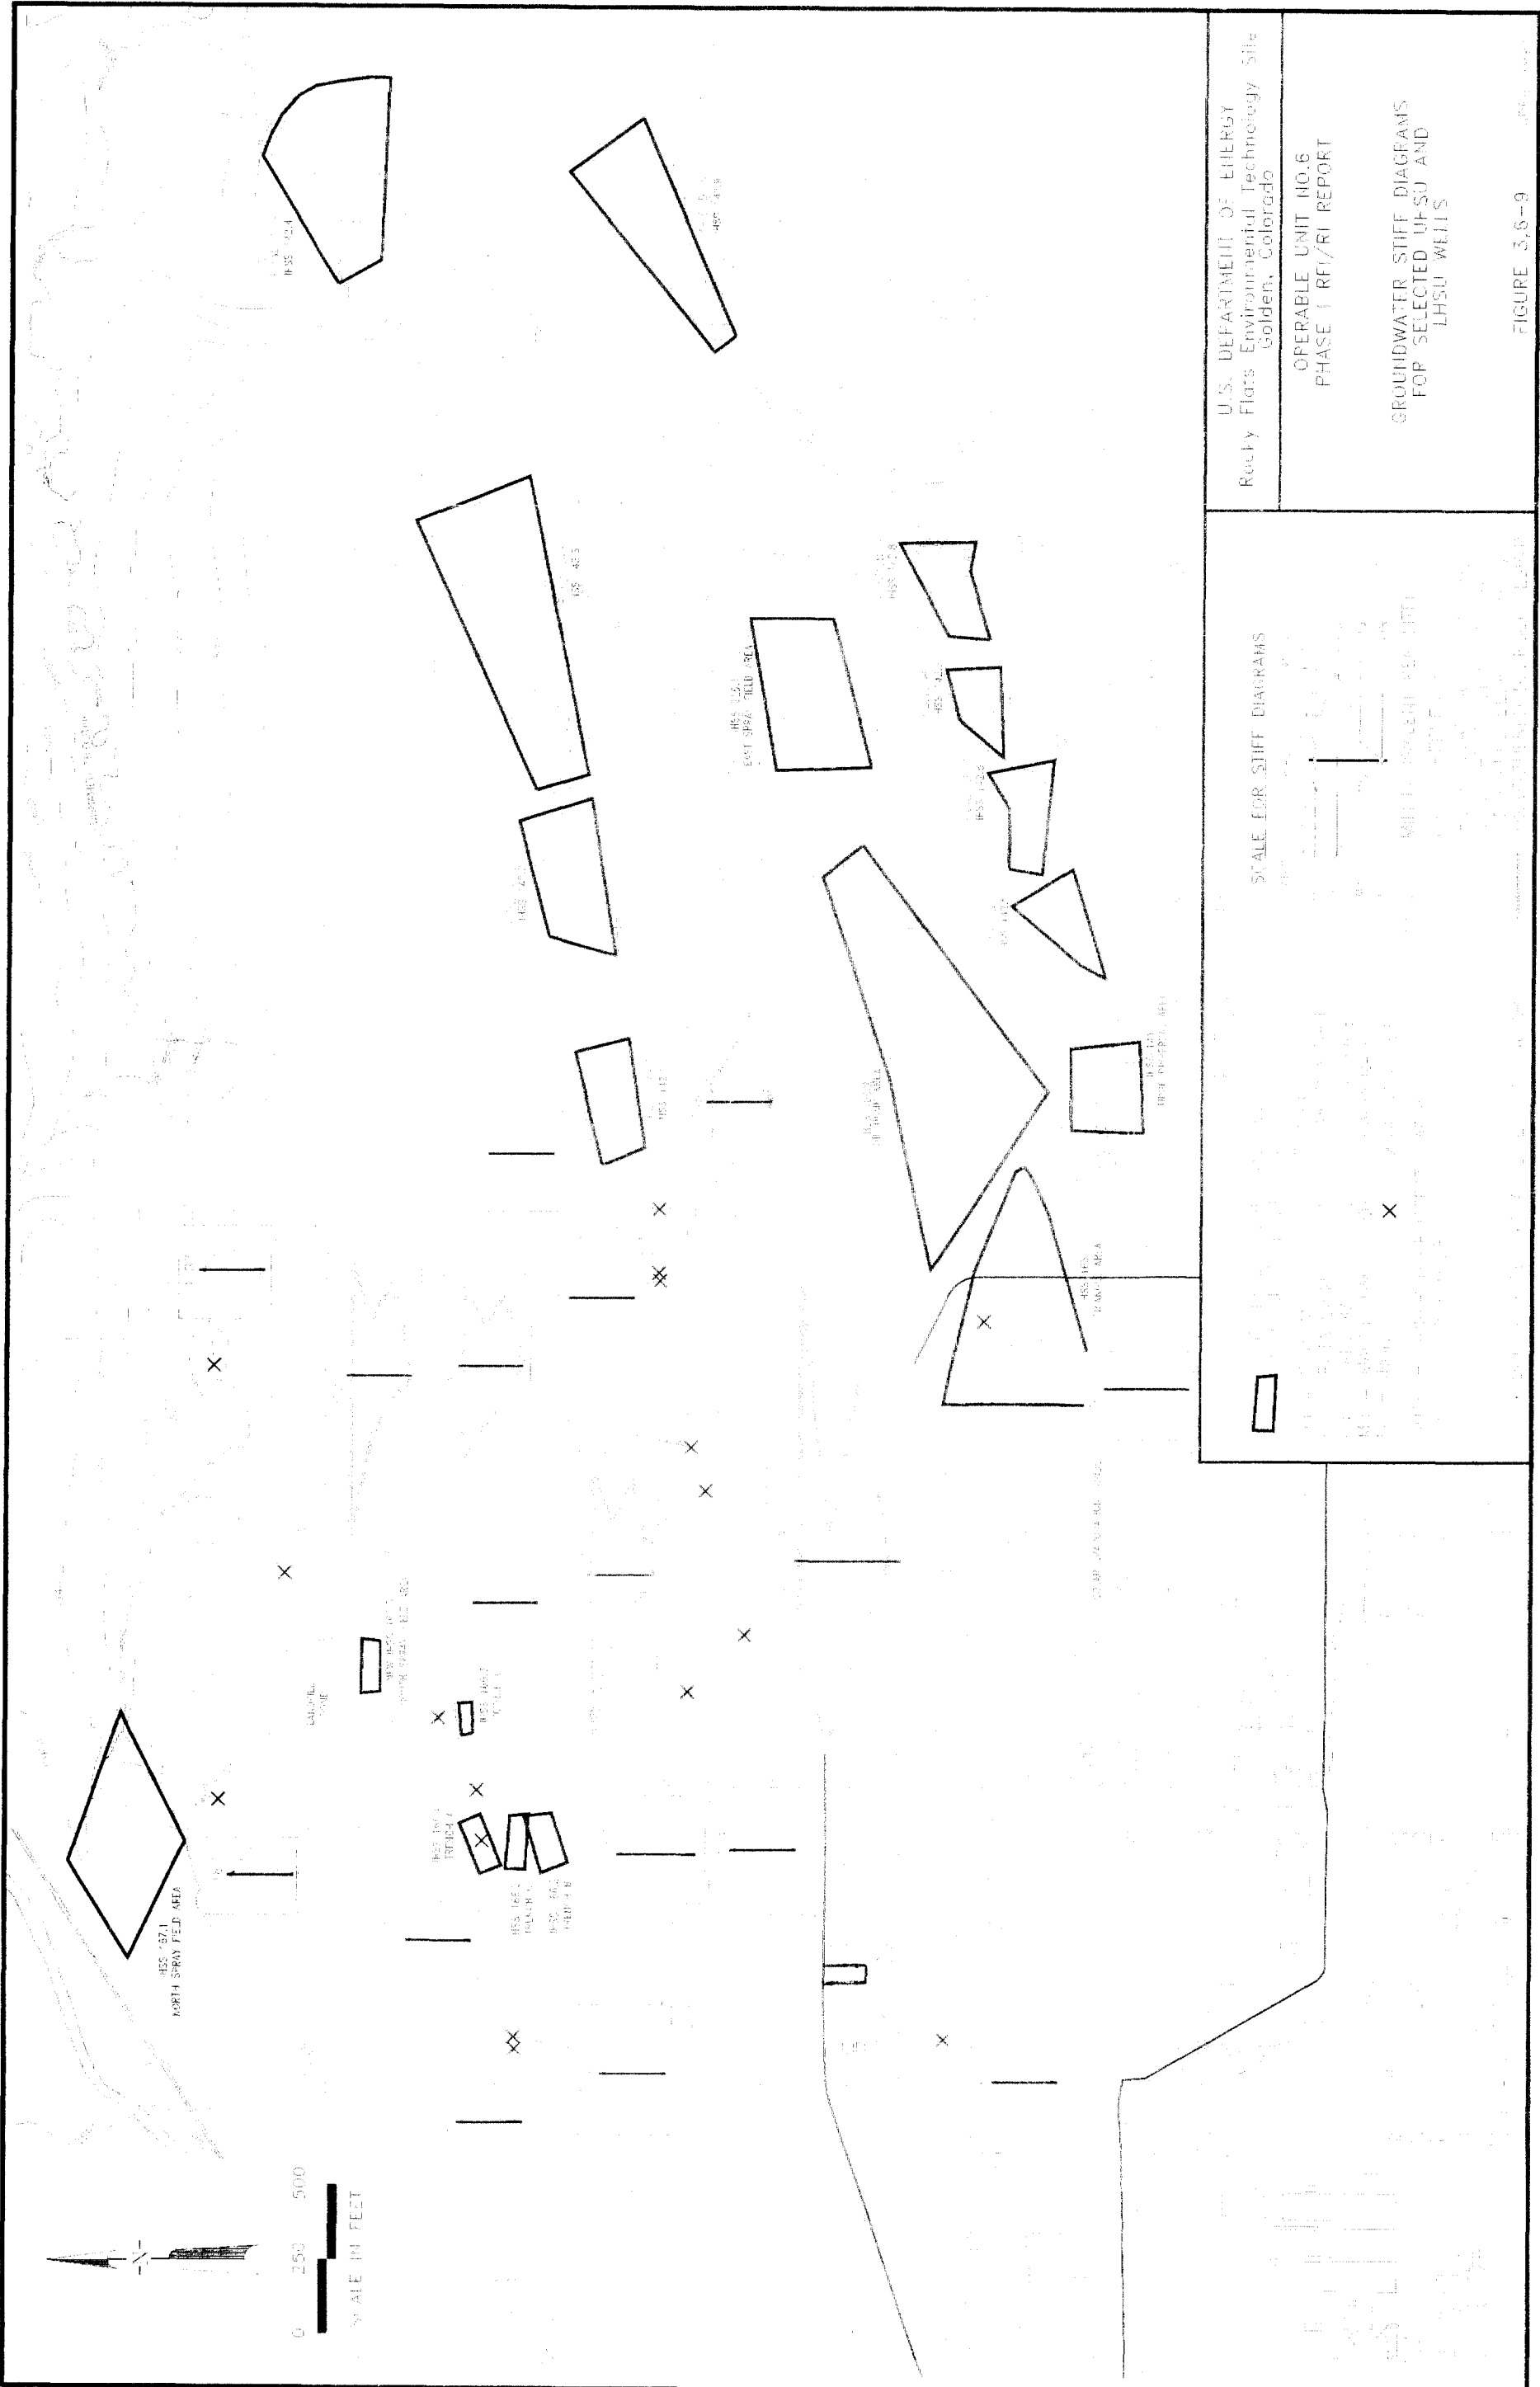
GROUNDWATER STIFF DIAGRAMS
FOR SELECTED UFSU AND
LHSU WELLS

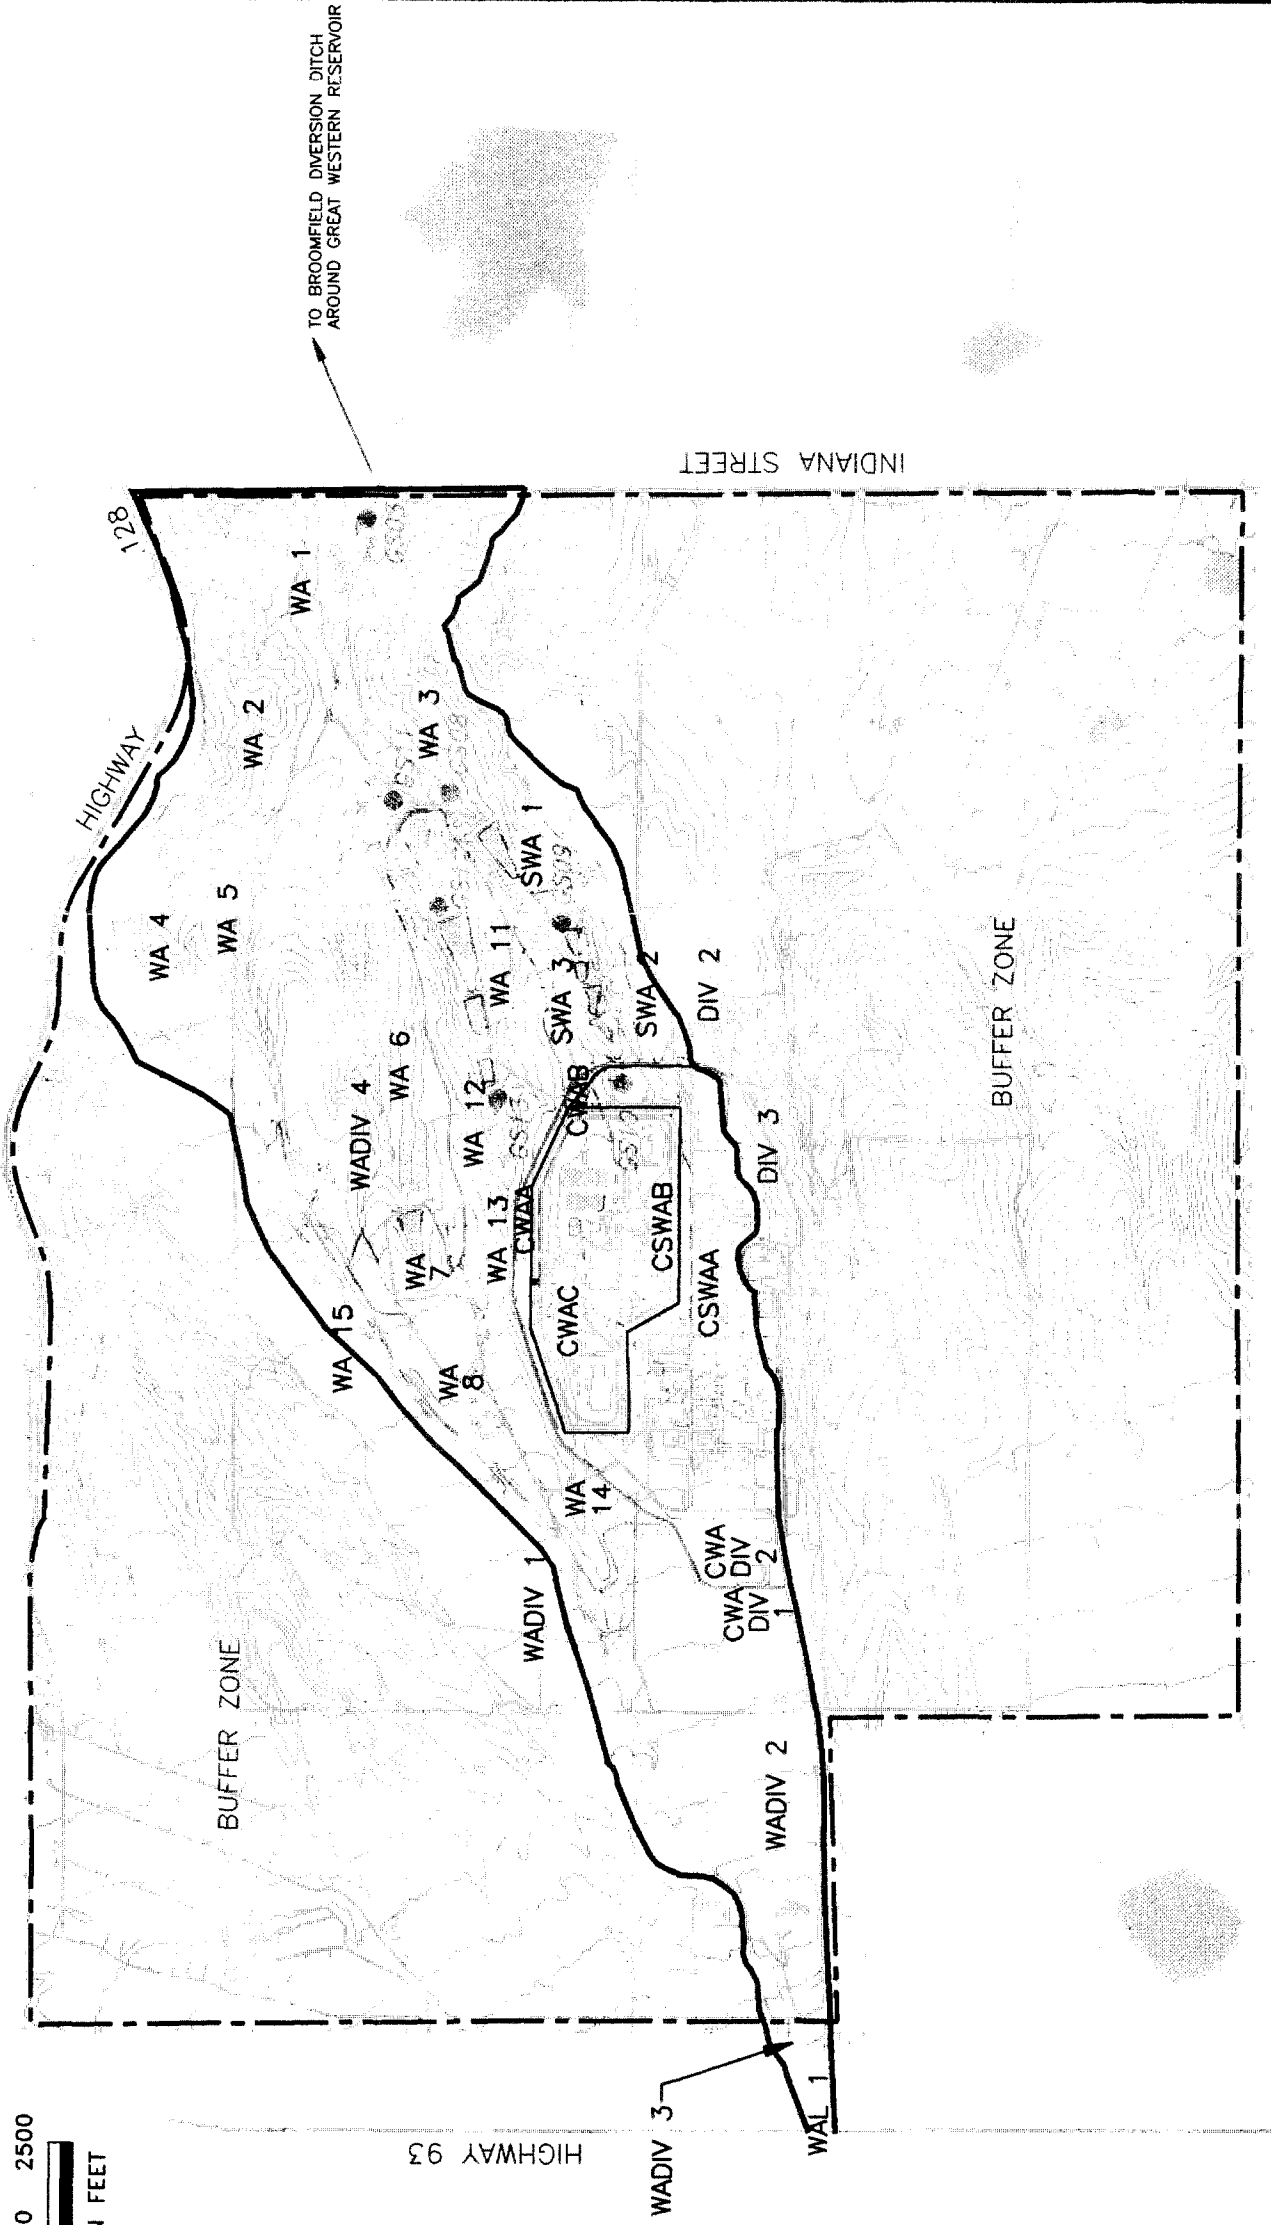
FIGURE 3.7-1 JUNE 1995

WALNUT CREEK DRAINAGE
BASIN BOUNDARY (UPSTREAM
OF INDIANA STREET)

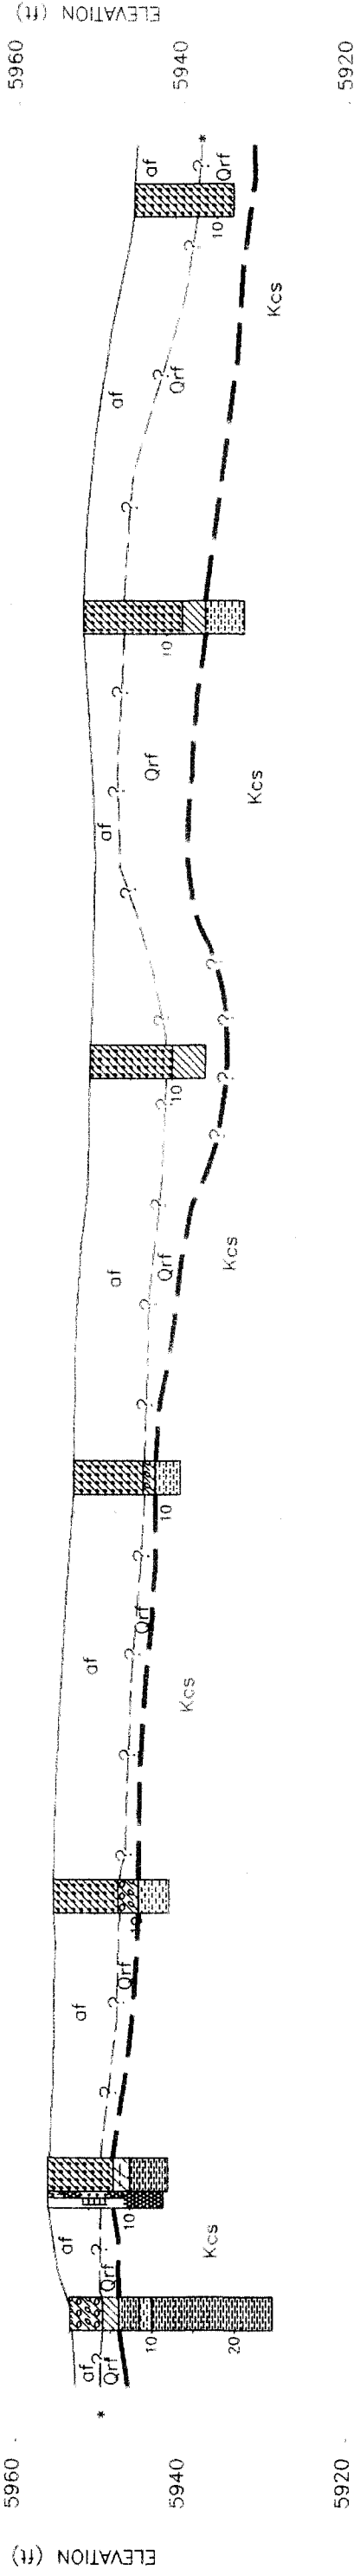
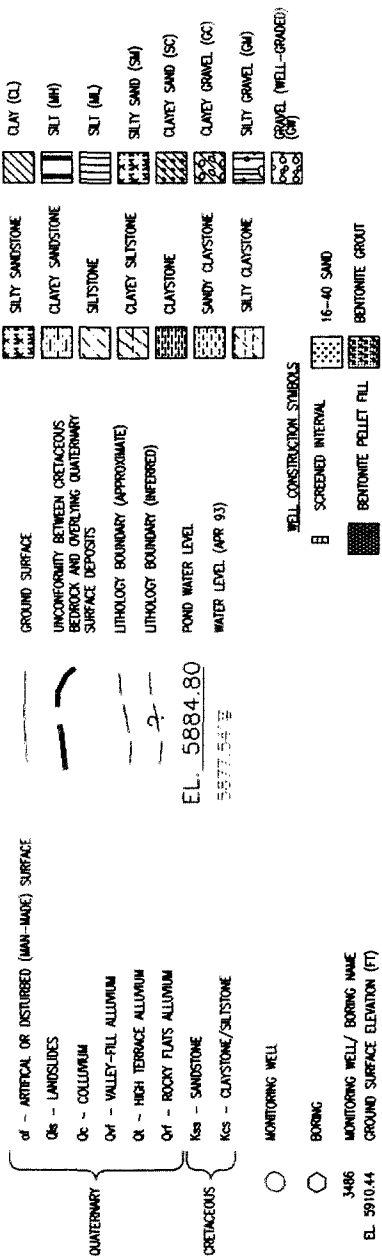
FIGURE 3.9-3
APRIL 1995

* af/Qrf CONTACT PLACED AT TOP OF CALICHE ZONE ENCOUNTERED IN BORINGS

OPERABLE UNIT NO. 6
PHASE 1 RFI/RI REPORT
WEST - EAST
GEOLOGIC CROSS SECTION E-E'
THROUGH IHSS 156.2

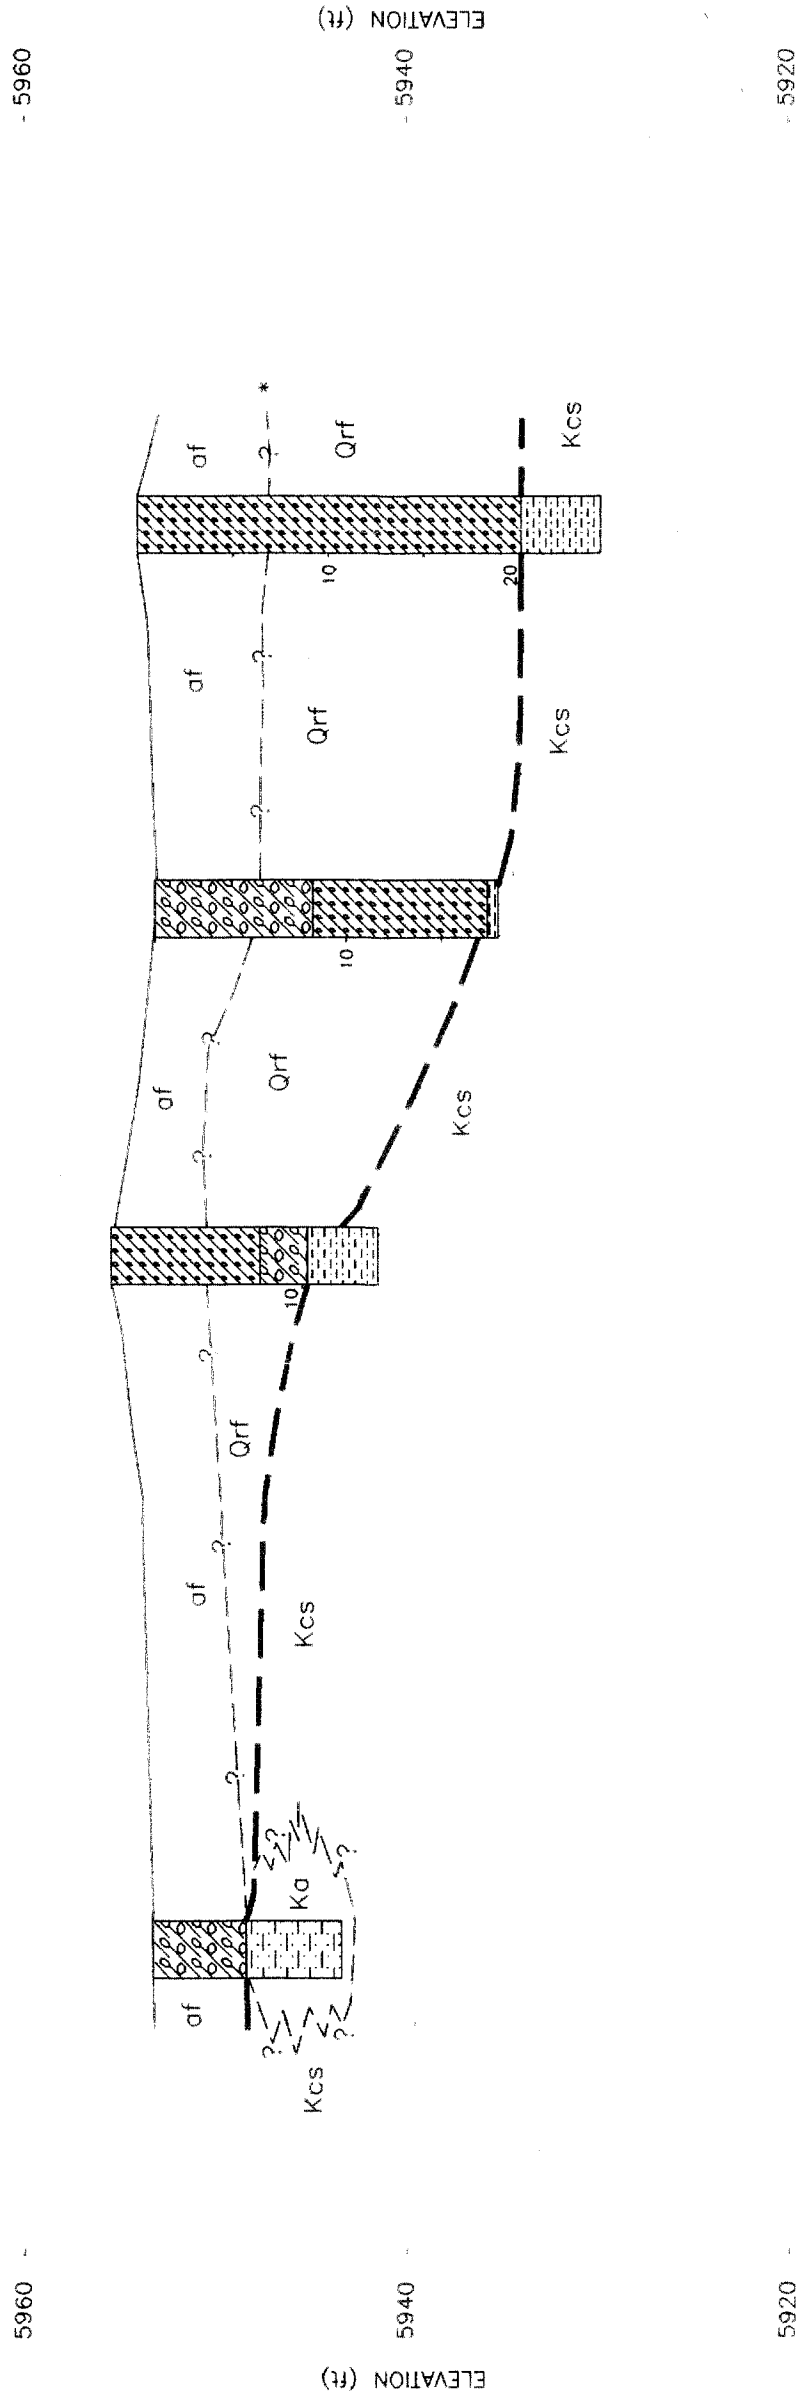
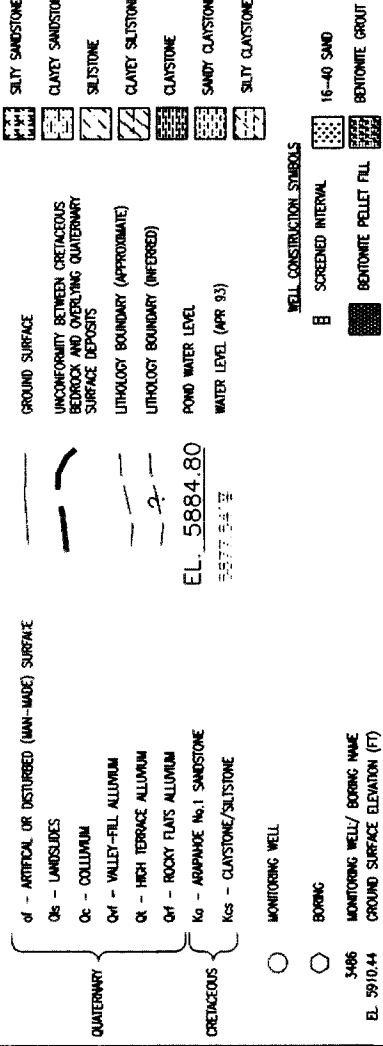
* af/Qrf CONTACT PLACED AT TOP OF CALICHE ZONE ENCOUNTERED IN BORINGS

OPERABLE UNIT NO. 6
PHASE 1 RFI/RI REPORT
SOUTHWEST - NORTHEAST
GEOLOGIC CROSS SECTION F-F'
THROUGH IHSS 156.2

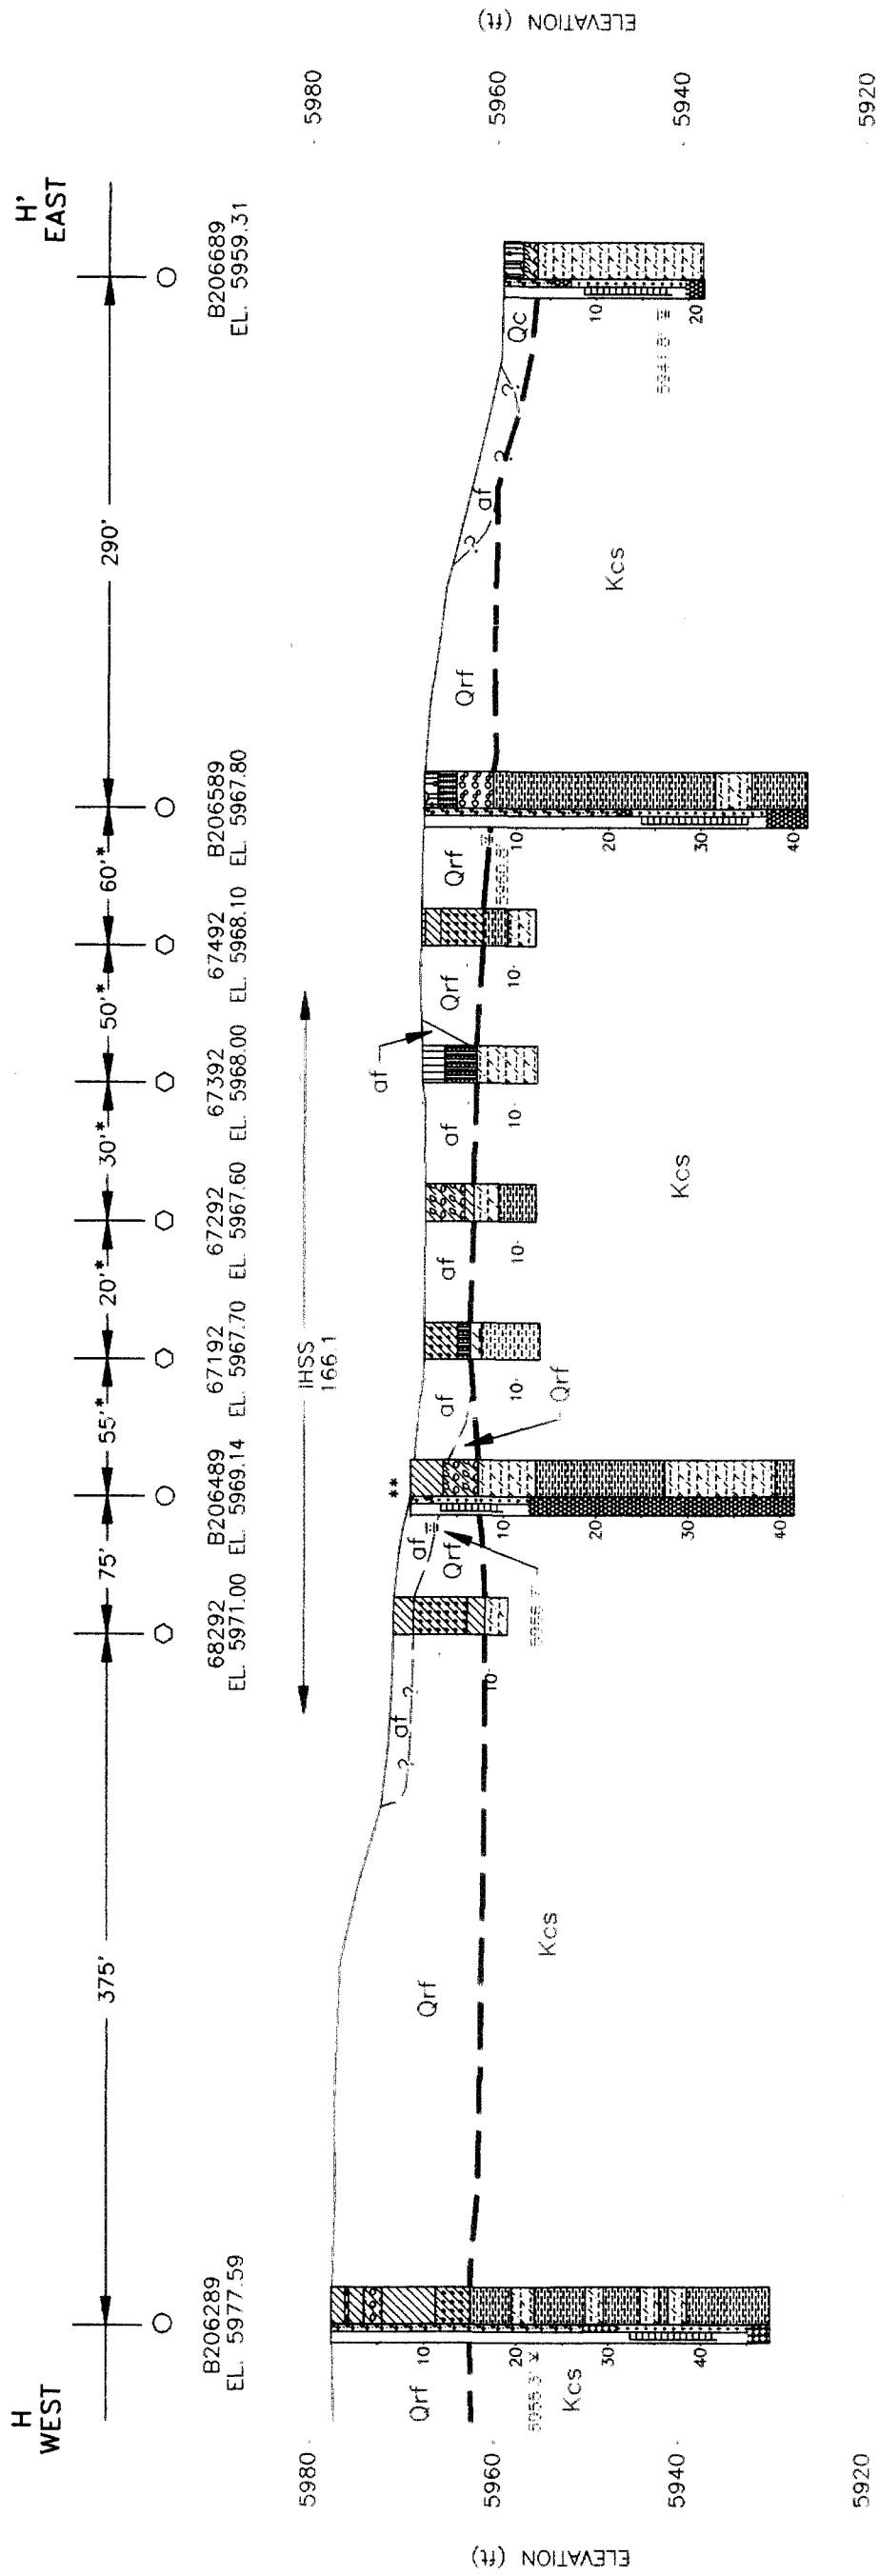
FIGURE 3.9-6 APRIL 1995

* DISTANCES BETWEEN BORINGS B206489, 67192, 67292, 67392, 67492, AND B206589 ARE NOT TO SCALE FOR PURPOSE OF CLARITY.

** TRENCH A BOUNDARY HIDDEN BY LITHOLOGY LOG AT WELL B206489.

OPERABLE UNIT NO. 6
PHASE I RFI/RI REPORT
WEST-EAST
GEOLOGIC CROSS SECTION H-H'
THROUGH IHSS 166.1

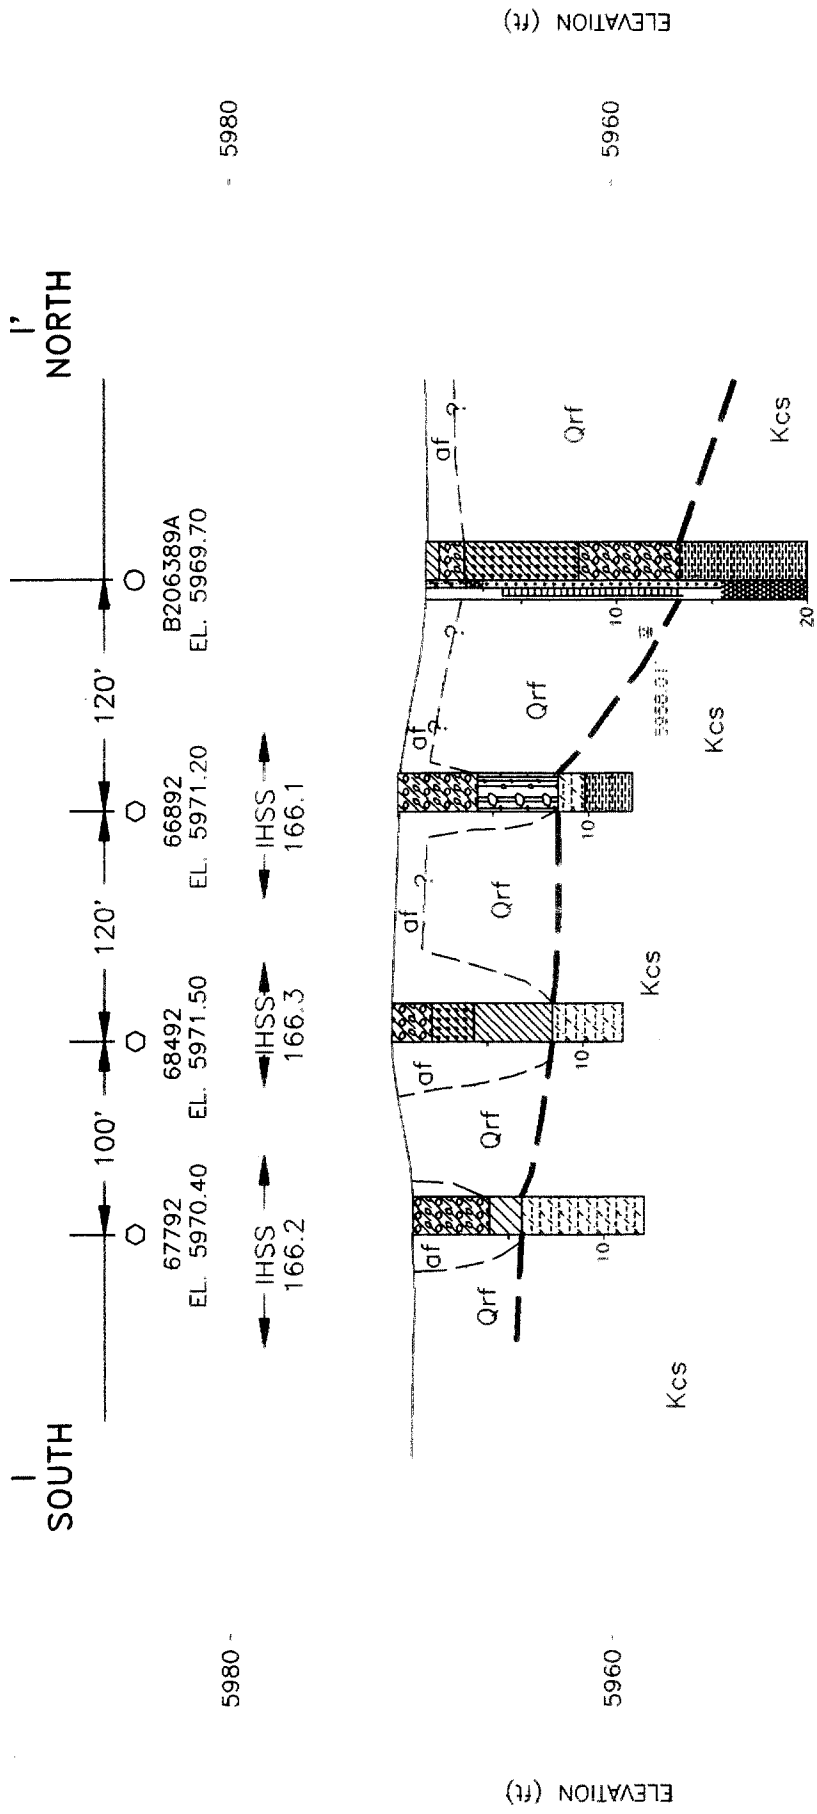
FIGURE 3.9-7 APRIL 1995

SOUTH-NORTH
GEOLOGIC CROSS SECTION I-I'
THROUGH IHSSs 166.1 - 166.3
